ERDC/CERL SR-05-3

Freshwater Corrosion in the Duluth – Superior Harbor

Summary of Initial Workshop Findings,
9 September 2004

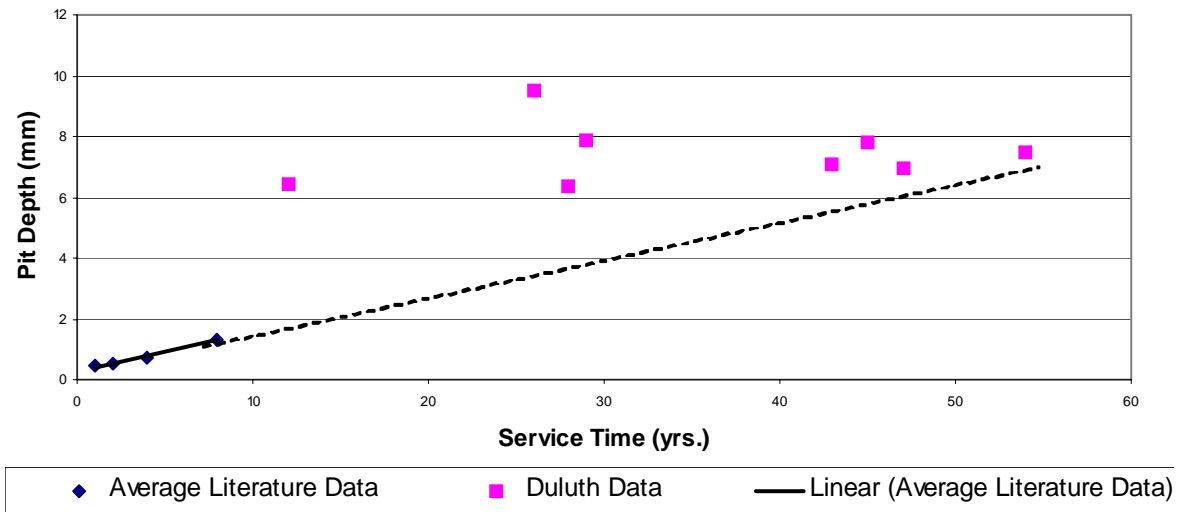
Comparison of Pit Depth Thickness Measurements at Various Locations on Duluth Harbor Sheet Pile Compared with Averaged Published Pit Depth Measurements for Comparable Materials in Fresh Water

In the graph below the maximum pit data gathered from multiple sites by Krech Ojard & Associates is analyzed with respect to literature data published* for three freshwater rivers (Monongahela River – Charleroi, PA; Allegheny River – Kittanning, PA; Mississippi River – Winfield, MO). The comparison is for the plain carbon steel results only. For each period (1, 2, 4, and 8 years) the data from all three rivers were averaged together. One of the main concerns is that corrosion rate data is typically used for comparing the corrosive effects of differing environments. The pitting process is not well understood (e.g., determination of initiation time, the role of passivity and passive film breakdown with respect to local environmental conditions, etc.) and is not necessarily representative of the relative corrosiveness between two environments. However, given that this was the only direct quantitative data available and that there was applicable published data to compare it to, this somewhat flawed analysis was undertaken. Another caveat to point out is that each DSH data point is a single measurement. Therefore, statistical analysis as to mean, variance, error, etc. is not possible. Further, maximum pit depth may not have been measured according to generally accepted practices, such as with a lever type pipeline pit gage, or a L.S. Starrett Co. type device.

With that said, the following interpretation is of interest. The conjecture is that approximately 30 years ago the ongoing rate of corrosive degradation in DSH underwent a significant and, thereafter, persistent increase. As shown on the following graph, the four data points for 30 years or less exposure show a significant increase in maximum pit depth compared to the linear projection from the collective freshwater data. This is in marked contrast to the four data points for exposure times exceeding 40 years. One interpretation of this is that longer ex-

posures include an increasingly longer proportion of service life in the “low corrosion” regime where the time-averaged rate of maximum pit growth would be less. The net effect for these older samples is a shallower maximum pit depth than would be expected under a more constant corrosion rate.
